## **GARIBALDI URBAN RENEWAL AGENCY (GURA) REGULAR MEETING**

1. GURA Application: 901 Garibaldi Avenue

901 Garibaldi Ave Garibaldi Or

**Inspection Date:**  
6/05/2025

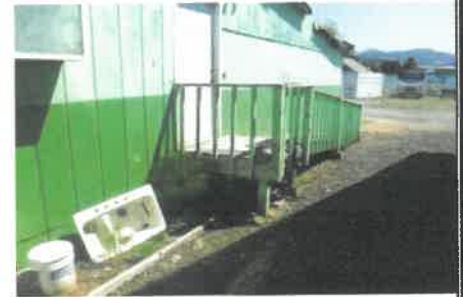
Supports and several pieces of decking have deterioration.

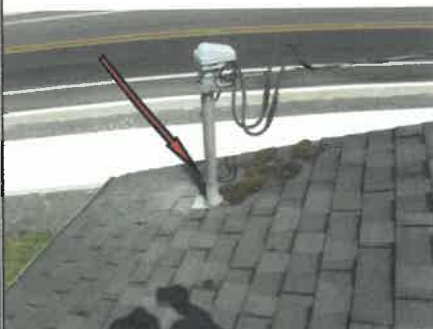
Service drop mast is sealed with mastic. Recommend using a rubber seal.

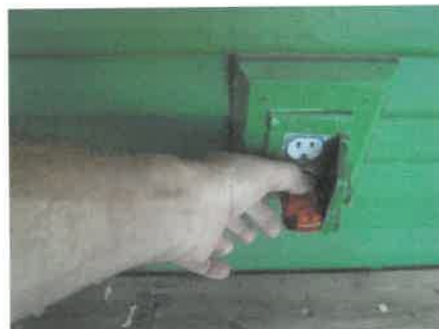
Exterior outlet isn't GFCI protected.

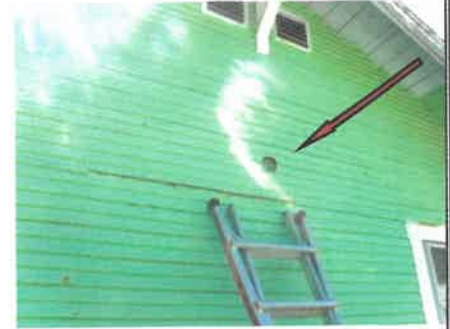
Live electrical was found in an open junction box (exterior) at the North gable.

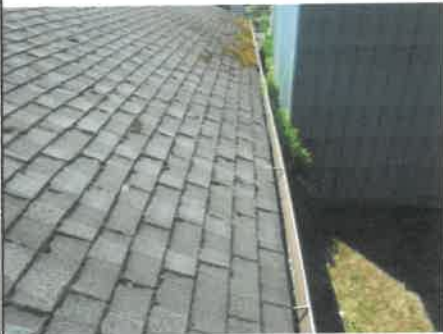
Gutters have a small amount of debris.

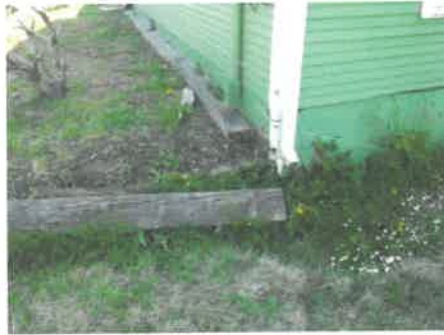
Recommend adding 6-8 foot downspout extensions to divert runoff away from the structure.

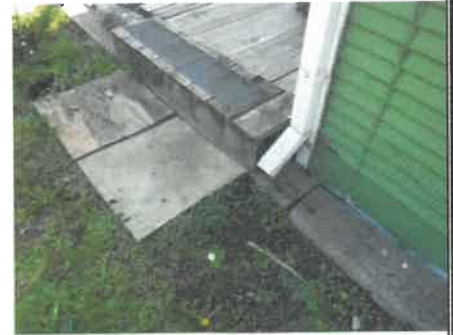
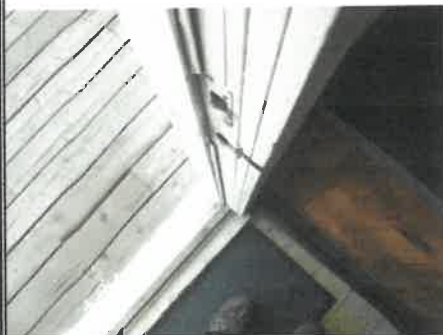
Exterior door weather-stripping is older and upgrading is recommended.

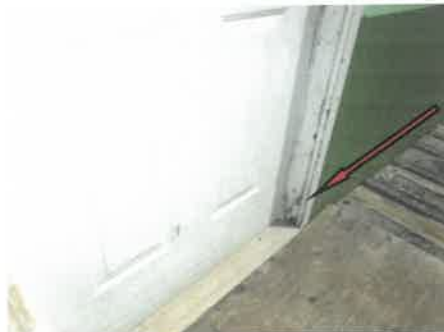
Rear entrance door has deterioration/damage to the frame and door.

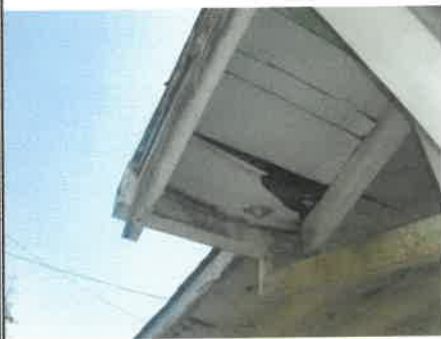
Exterior of structure needs repairs.

NE shown.

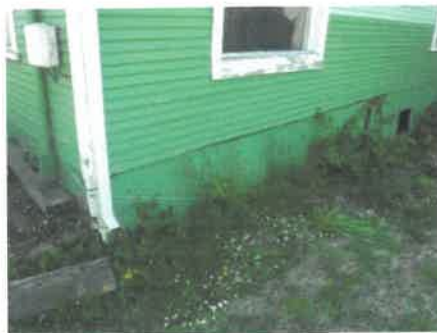
Skirting has deterioration. Openings in the skirting will allow pests to intrude.

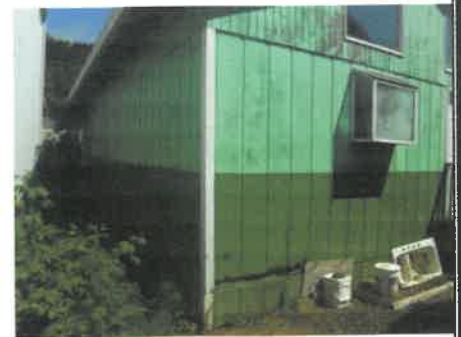
Siding has deterioration mostly at the South.

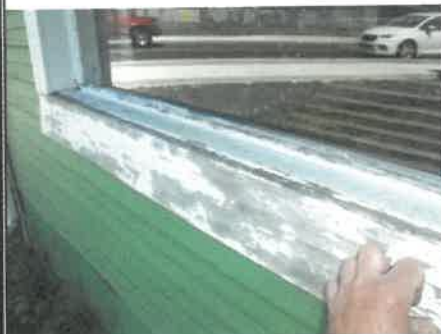
Wood framed windows need repair.

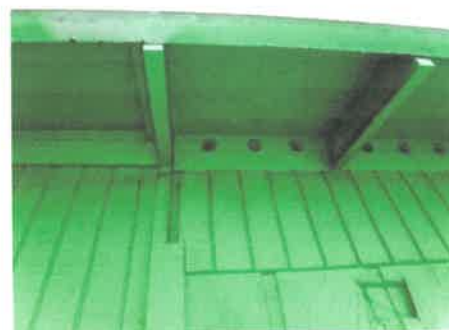
Monitor eave vent screens for deterioration.

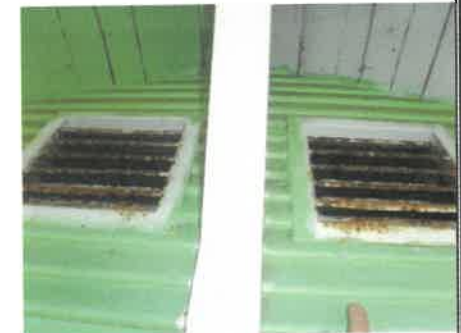
Gable end vent screens need replacement.

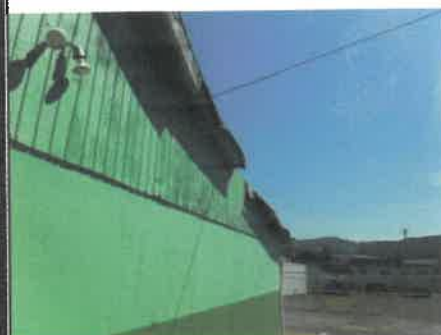
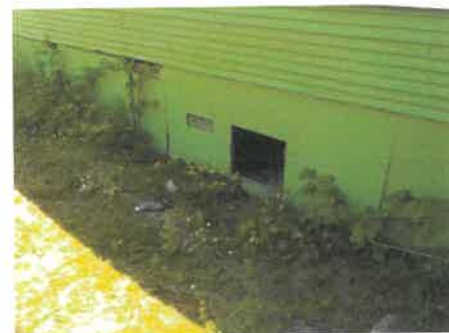
Skirting has ground contact in several areas causing deterioration.

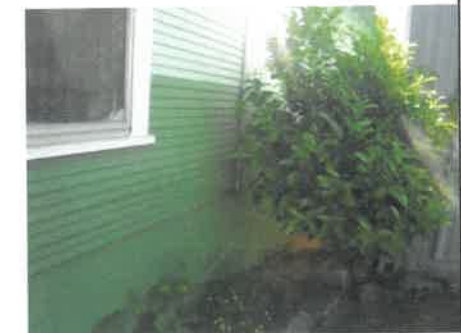
Keep vegetation trimmed back from siding.

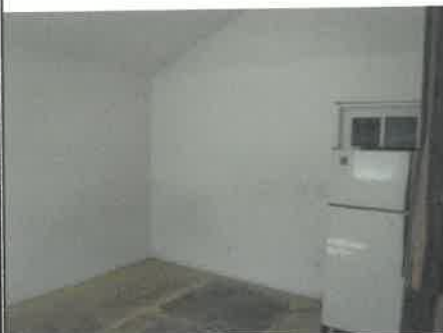
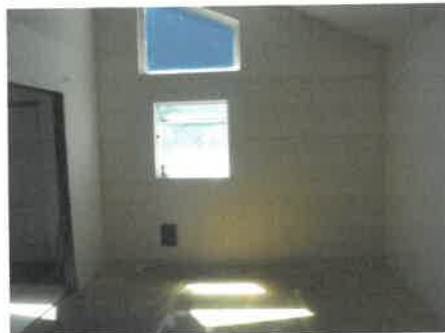
One pane in the garden window is broken. Several panes have failed seals.

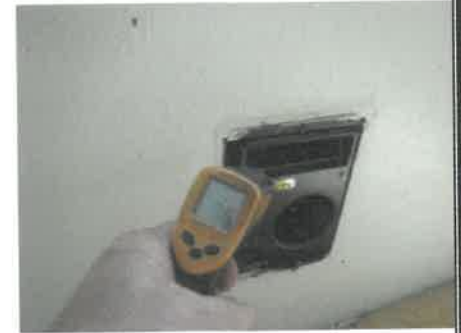
Cadet wall heater is inoperable.

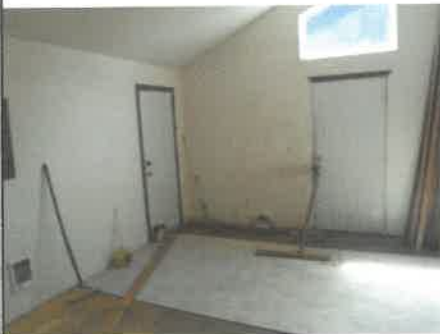
Exterior door has damage.

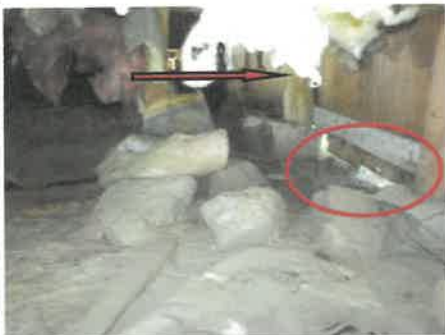
Several leaning support posts were found.  
Seal openings in the skirting to prevent pest intrusion.

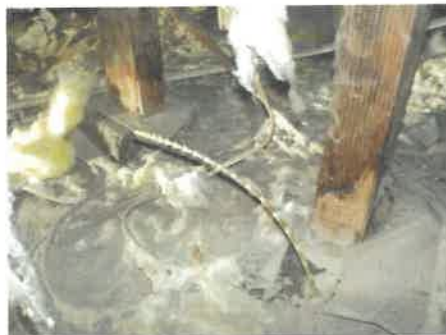
Standing water has caused deterioration to several support posts.

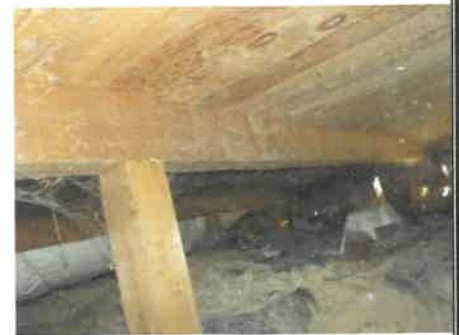
Anobiidae beetle frass was found in several areas. Increasing ventilation and keeping the area dry would be helpful.

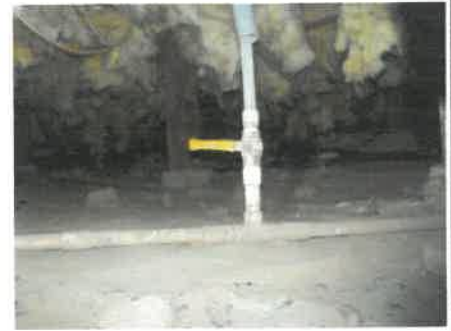
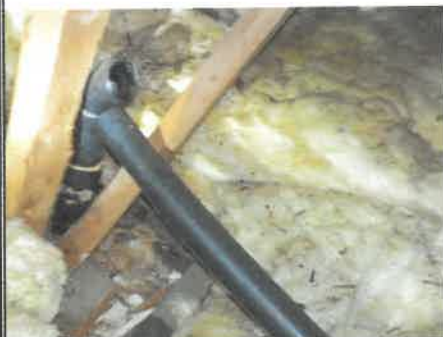
Plumbing vent lines (attic) need repair.

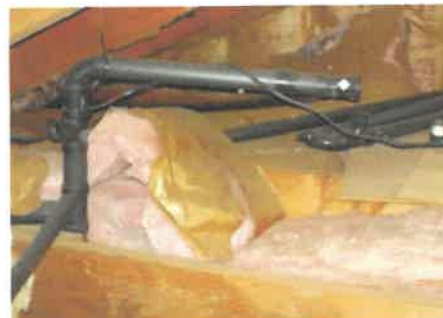
Plumbing vent in the attic wasn't extended to the exterior.

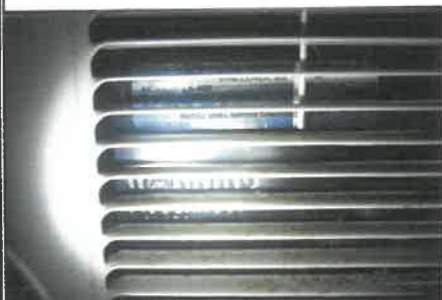
Prefix LX Cadet heater located in the commercial area has been recalled and should be replaced.

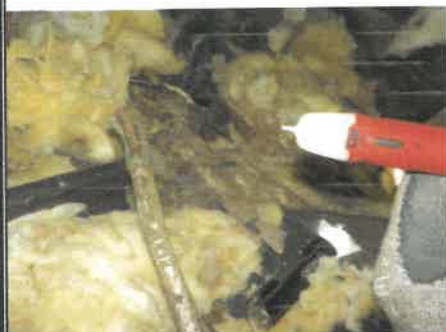
An unprotected electrical line was found in the crawlspace. Line isn't live. Removal is recommended.

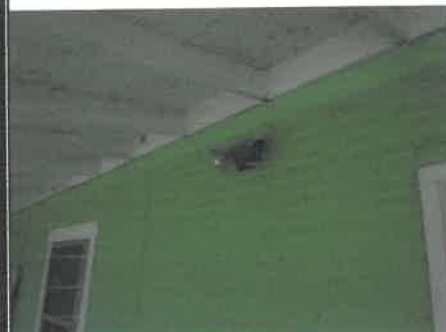
Motion detector light at the main entrance needs replacement.

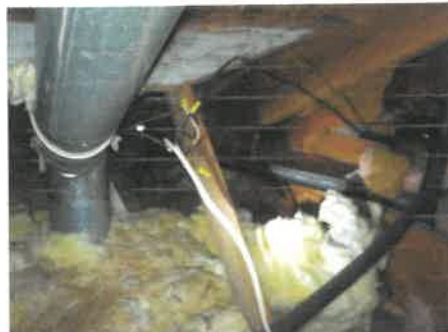
Exposed electrical connection (attic) should be in a junction box.
