## **GARIBALDI URBAN RENEWAL AGENCY (GURA) REGULAR MEETING**

1. GURA Application: 901 Garibaldi Avenue

901 Garibaldi Ave Garibaldi Or

**Inspection Date:**  
6/05/2025

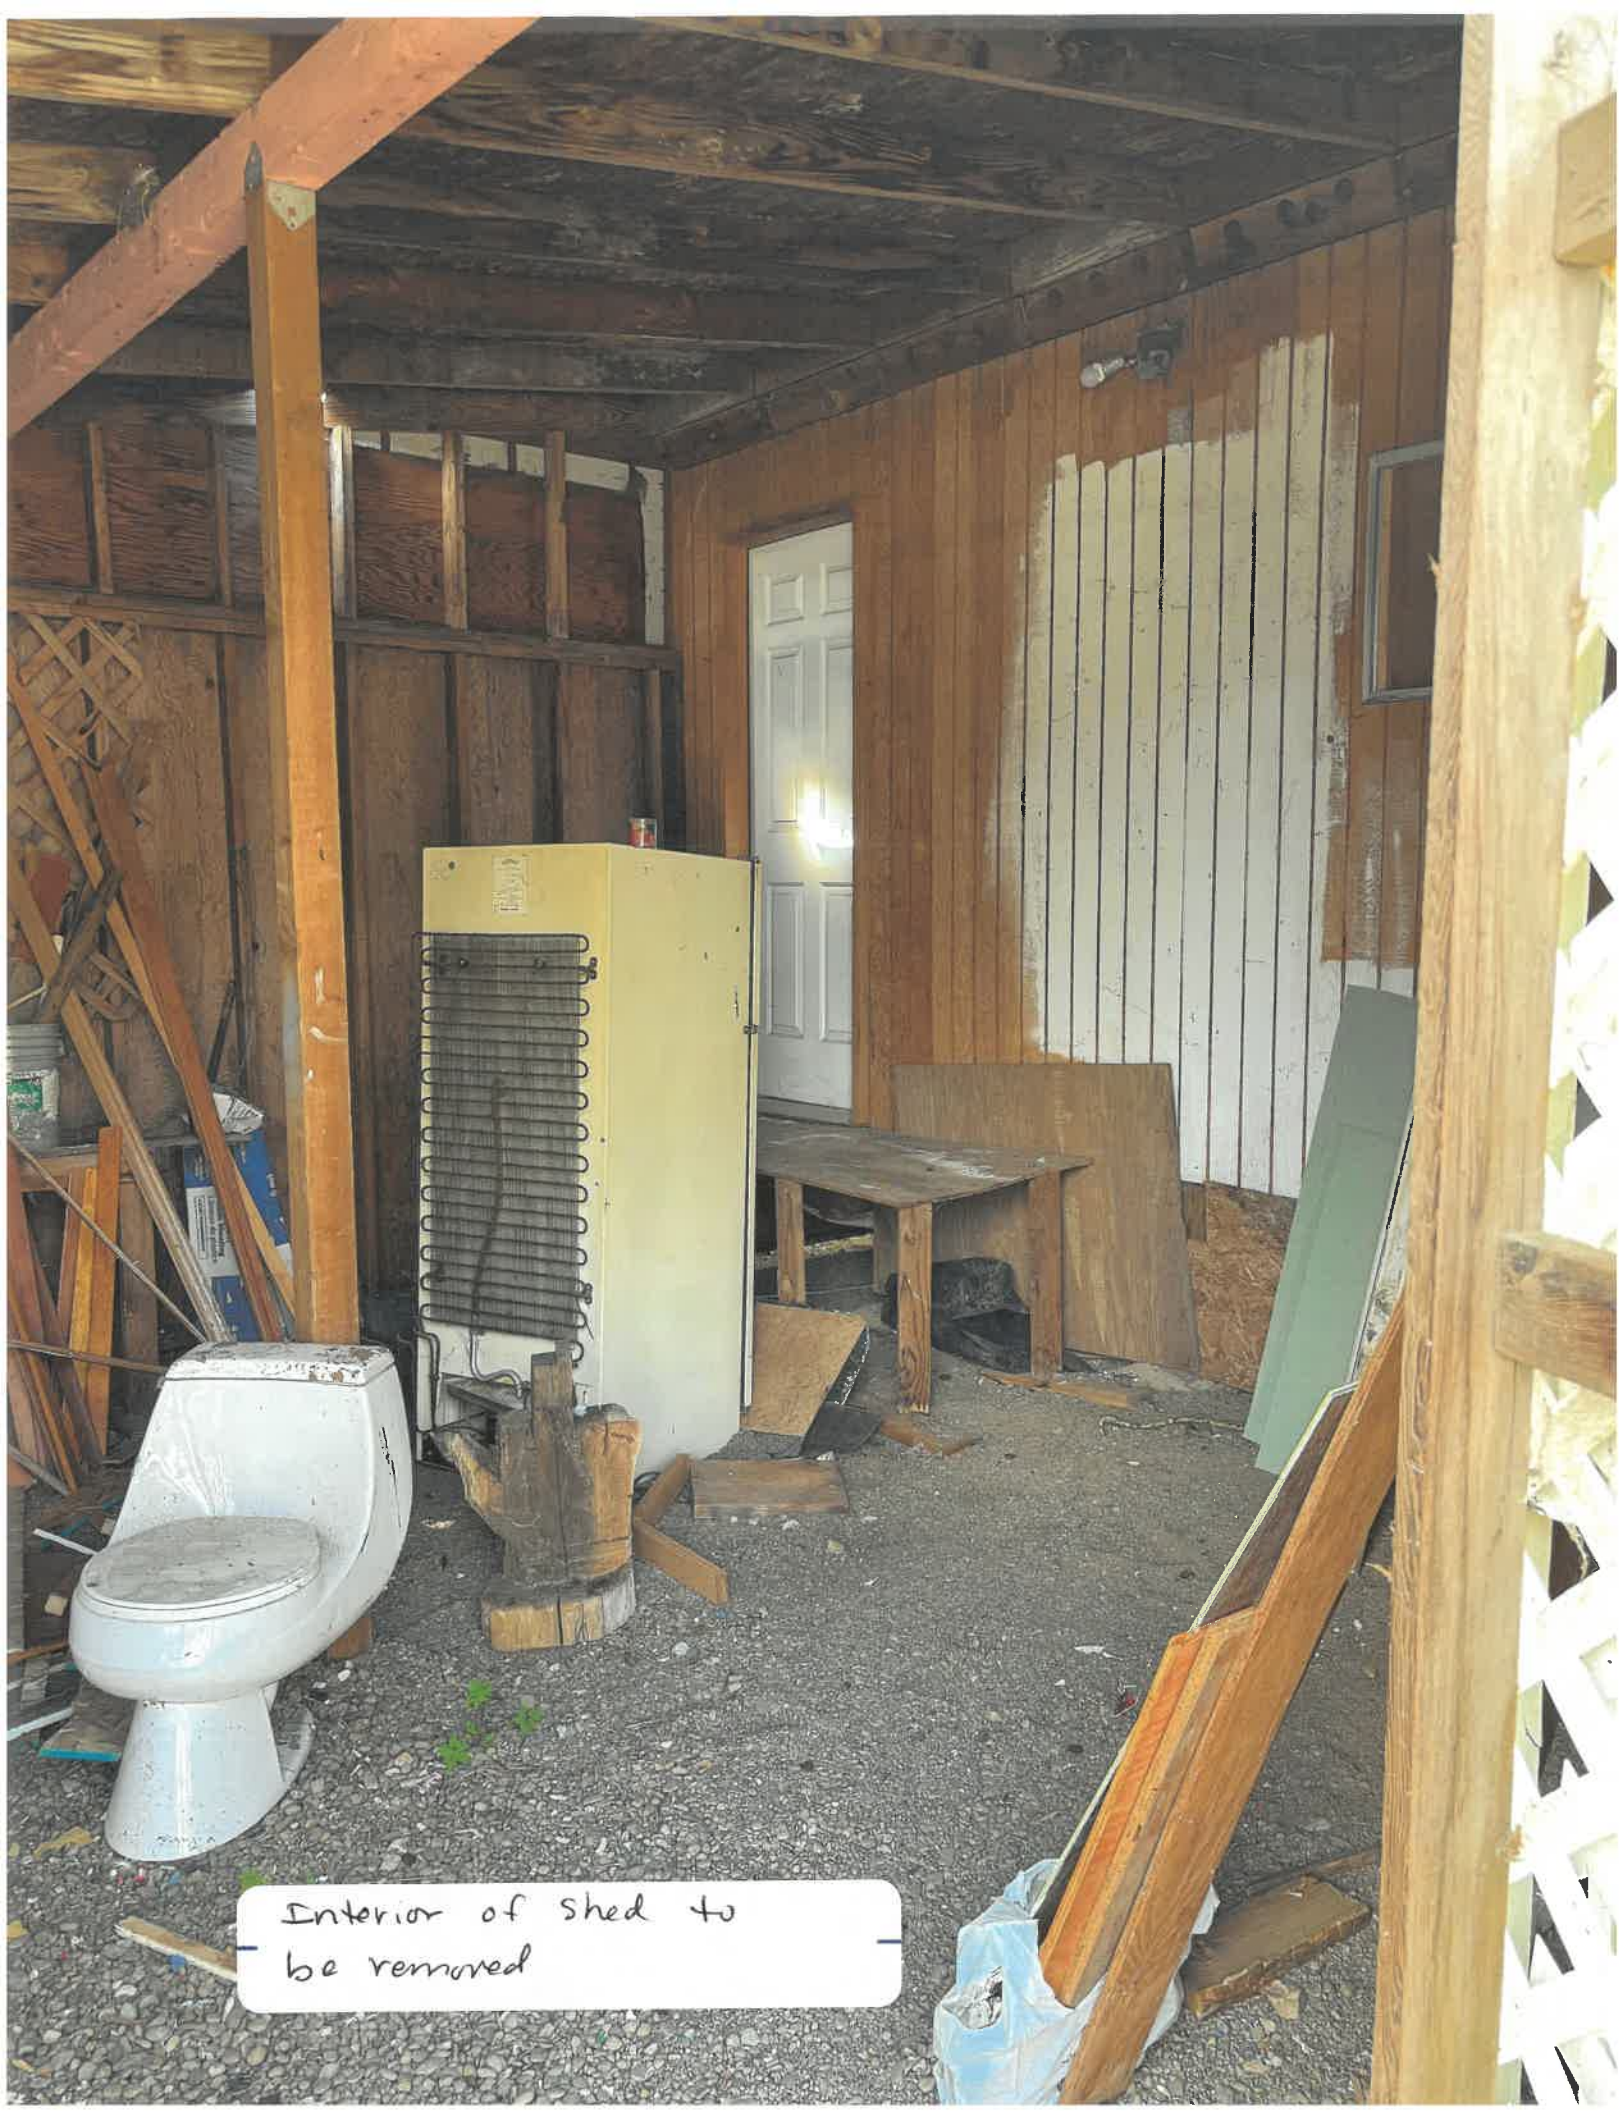
Interior of shed to  
be removed

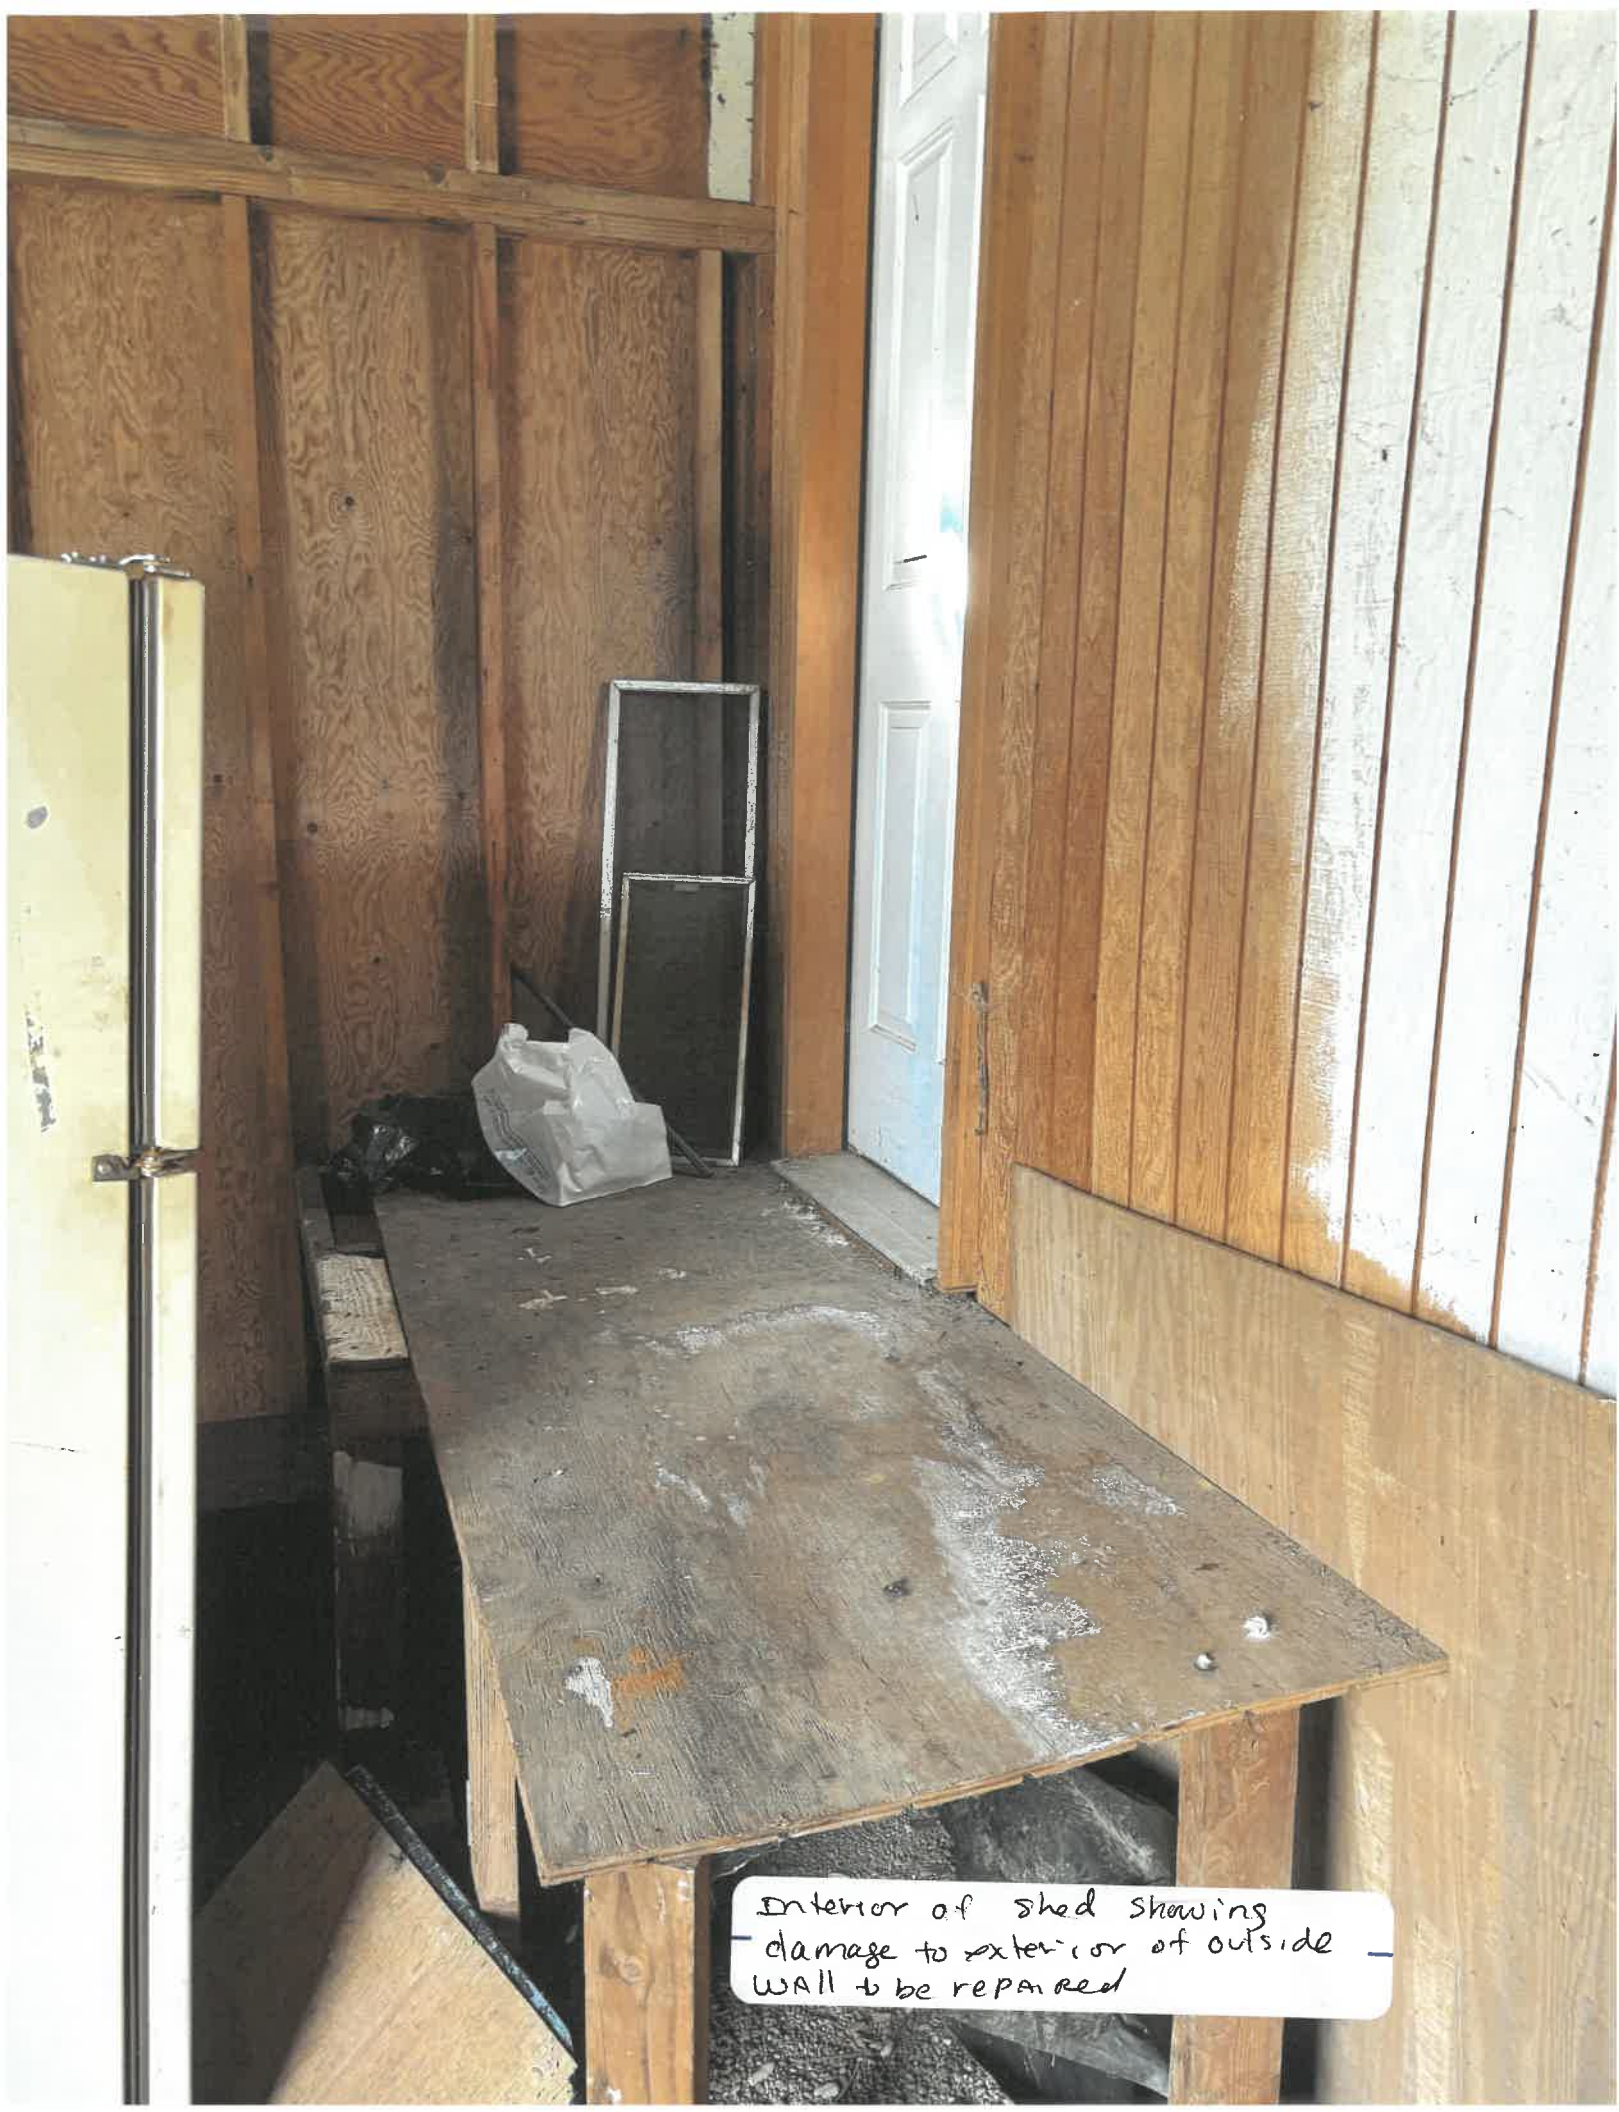
Interior of shed showing  
damage to exterior of outside  
wall to be repaired

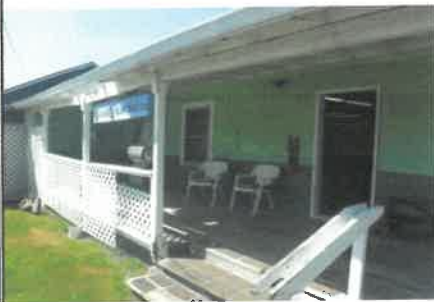
Main entrance porch floor framing isn't fully visible and condition wasn't determined.

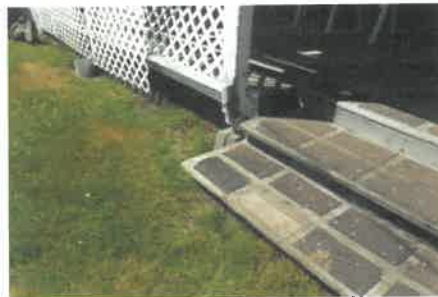
Porch and cover have deterioration. Refurbishing may not be feasible.

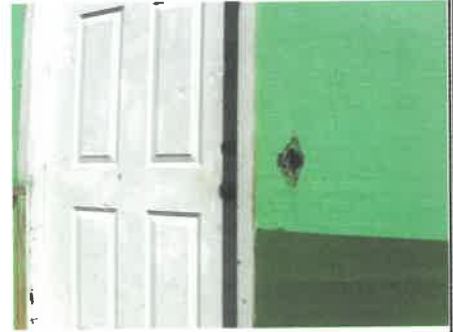
Rear entrance door has deterioration/damage to the frame and door.

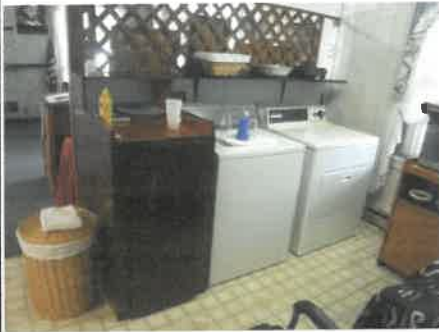
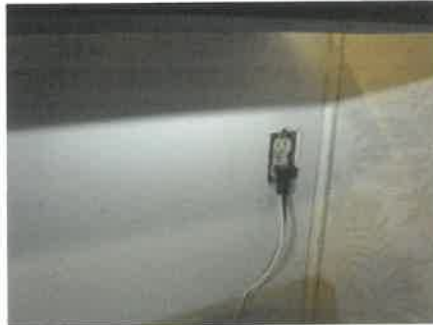
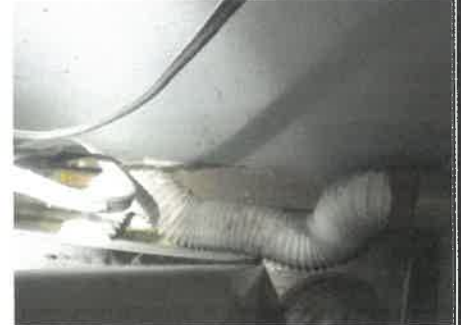
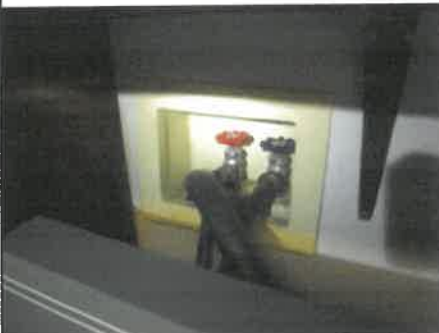
Laundry sink: ☐ N/A ☐ Yes ☐ No  
 Cross connections: ☐ Yes ☐ No  
 Dryer vented: ☐ N/A ☒ Wall ☐ Ceiling ☐ Floor ☐ Not vented  
☒ **PLASTIC DRYER VENT NOT RECOMMENDED** ☐ Not vented to Exterior ☒ Recommend repair ☒ Safety hazard  
 Electrical: Open ground/reverse polarity within 6' of water: ☒ Yes ☐ No ☒ Safety hazard  
 GFCI present: ☐ Yes ☒ No **Operable:** ☐ Yes ☐ No ☐ Recommend GFCI Receptacles  
 Appliances: ☒ Washer ☒ Dryer ☐ Water heater ☐ Furnace/Boiler  
 Washer hook-up lines/valves: ☐ Leaking ☐ Corroded ☐ Not visible  
 Gas Shut-off Valve: ☒ N/A ☐ Yes ☐ No ☐ Cap Needed ☐ Safety hazard ☐ Not visible

Monitor lines to the washing machine for leaks/deterioration.

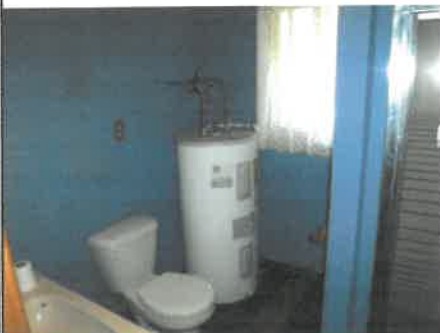
Window can be used for ventilation.

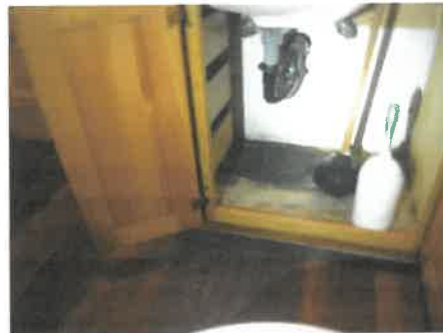
No leaks were detected under the sink at the time of inspection.

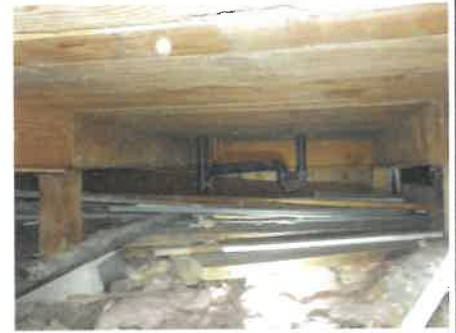
Plumbing lines under the bathroom were in satisfactory condition at the time of inspection (crawl space view).

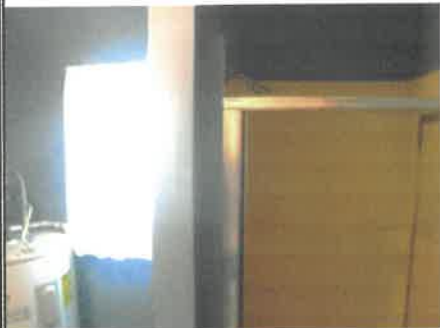
Window can be used for ventilation.

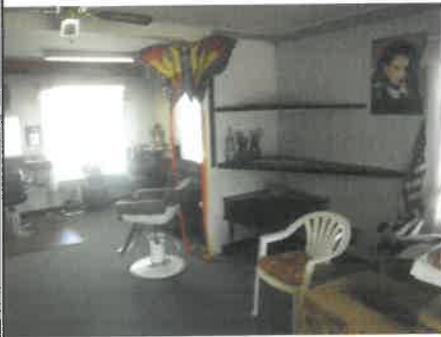
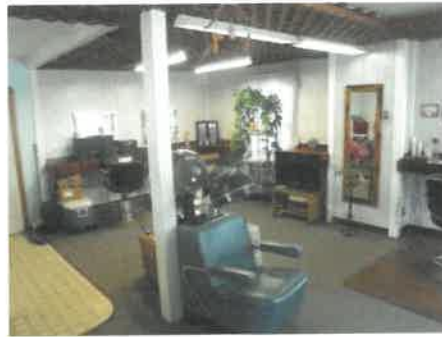
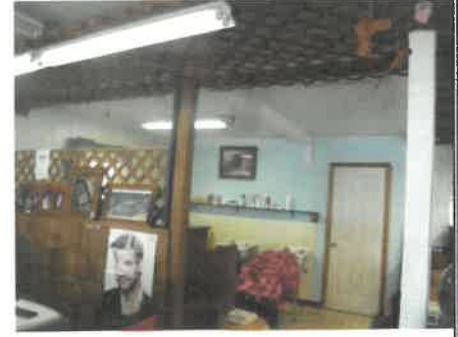
**LOCATION: NORTH  
COMMERCIAL**

Baseboard heaters are inoperable. Cadet wall heater is operable.

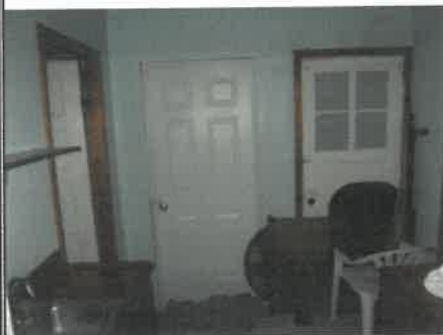
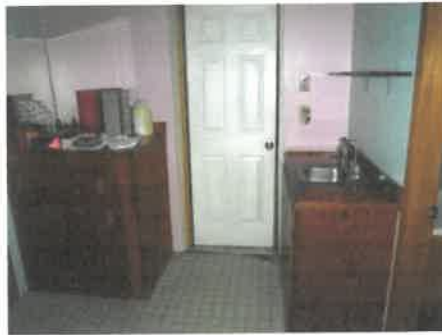
**LOCATION: CENTRAL  
COMMON AREA**

Light in fixture is inoperable. Bulb may be defective.

No leaks were detected under the sink at the time of inspection.

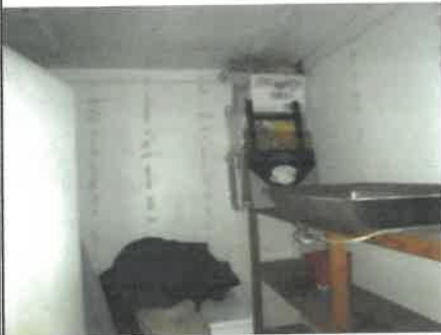
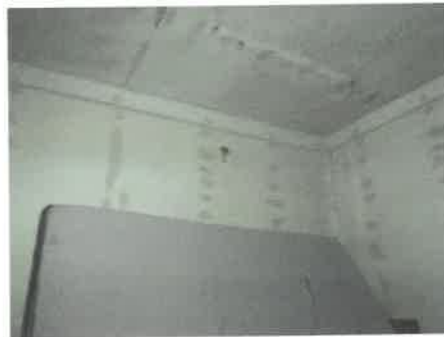
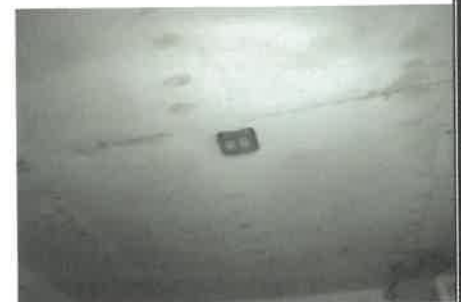
Use a stain blocking primer when repainting.

Room appears to be wired for a light.

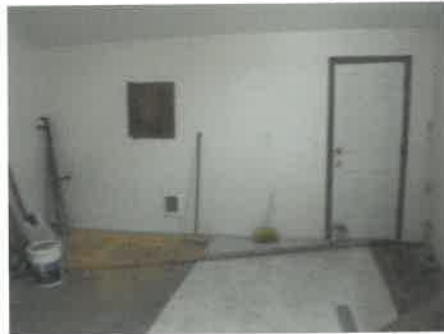
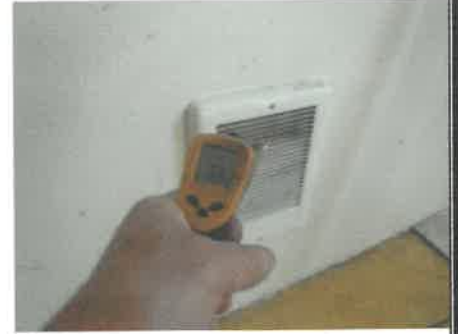
Exterior door has damage.

Cadet wall heater is inoperable.

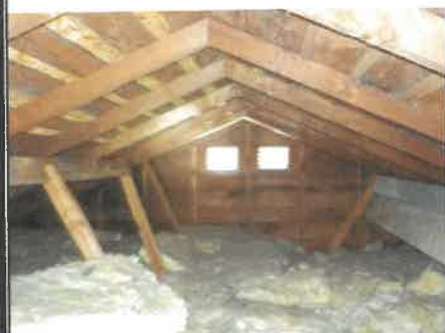
Gable end vent screens need replacing.

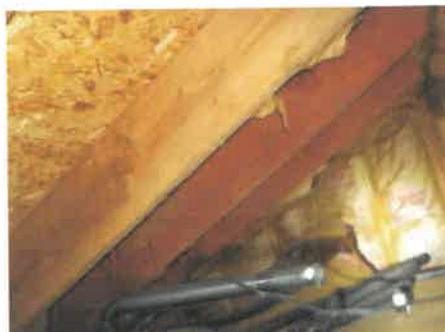
2x12 rafters are visible at the new construction section.

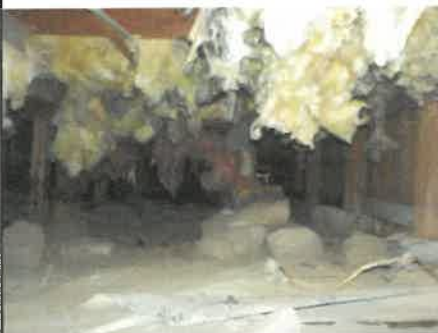
Insulation throughout the crawlspace had been displaced.

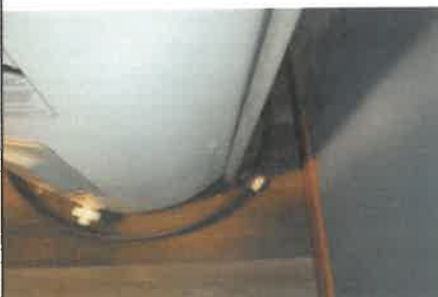
Water heater is equipped with a drip pan. Pan does not drain to the exterior. Monitor for moisture buildup.

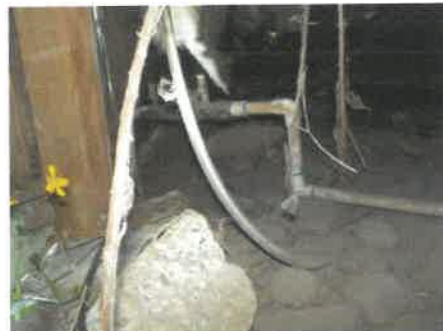
Water shutoff valve is located in the crawlspace inside the access panel.

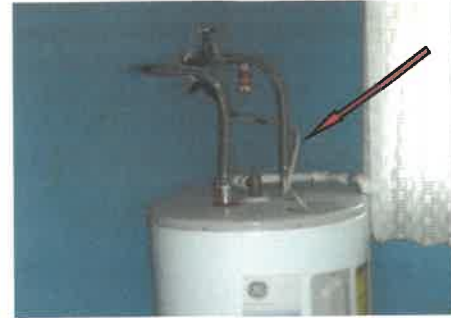
Electrical is exposed and should be protected in conduit.

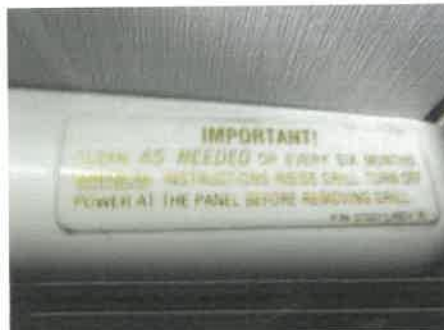
Prefix LX Cadet heater located in the commercial area has been recalled and should be replaced.

Cadet heaters located in the South rooms are not on recall. South heaters are inoperable.

Follow manufacturers' instructions for heater maintenance.

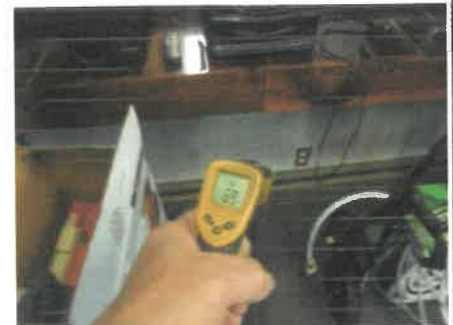
Baseboard heaters in the commercial area are inoperable.

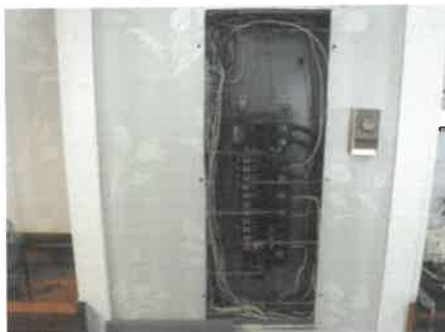
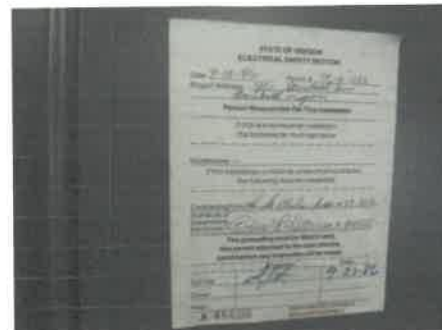
Panel installation had been approved by the local building department.
